# NYC DOT Sunrise Yard Facility

## Cast Study: Anchor Bolt Laser Scan Survey

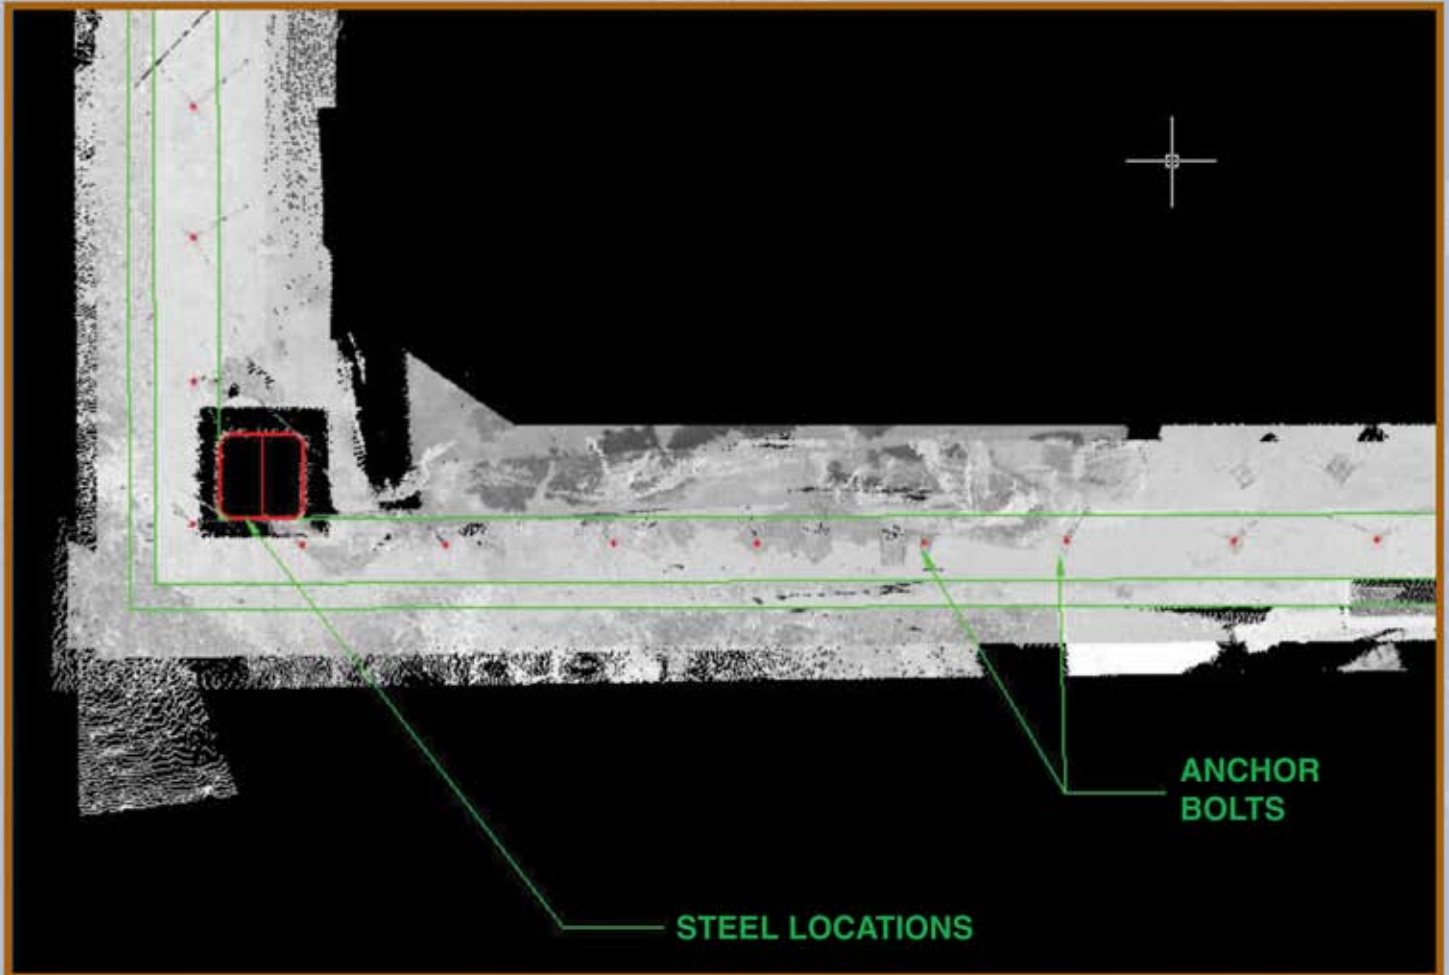
All existing anchor bolt locations are digitally captured in 3D space.

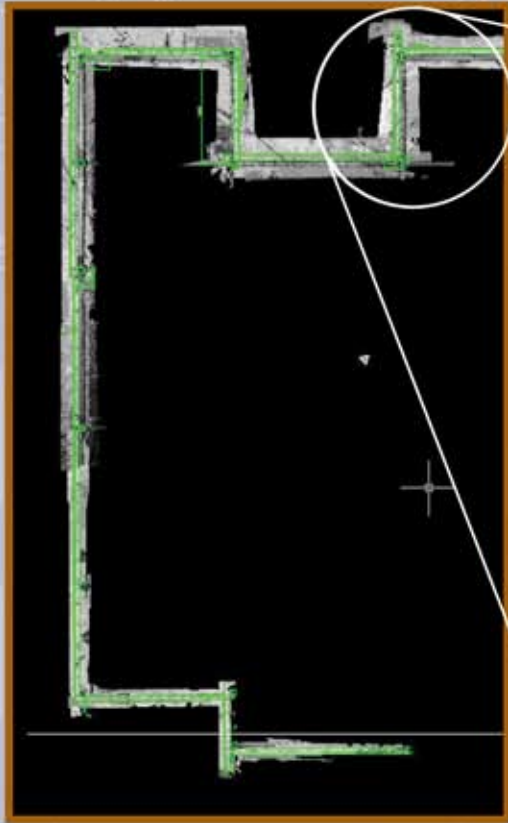
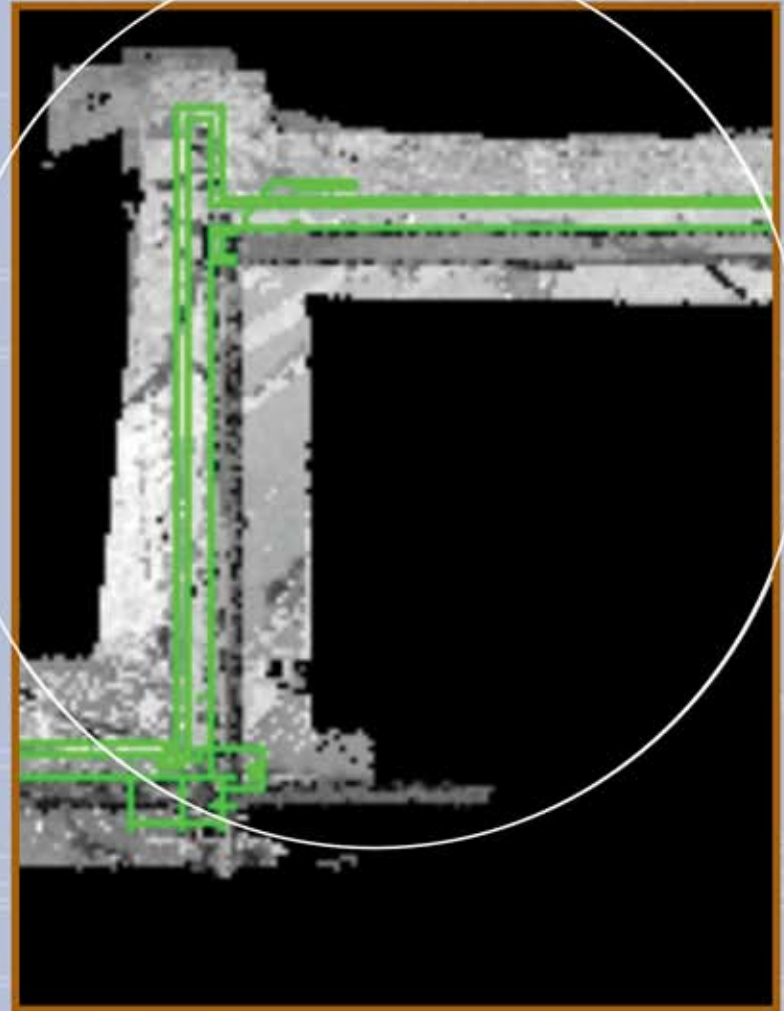
Scans files are processed in CAD software. A "slice" is taken through the 3D model and a section created one inch above concrete, where the bolt is "straight."

This allowed us to locate the true center point of the anchor bolt and the true location of the steel columns that may infringe on the setting of the cast stone sill.

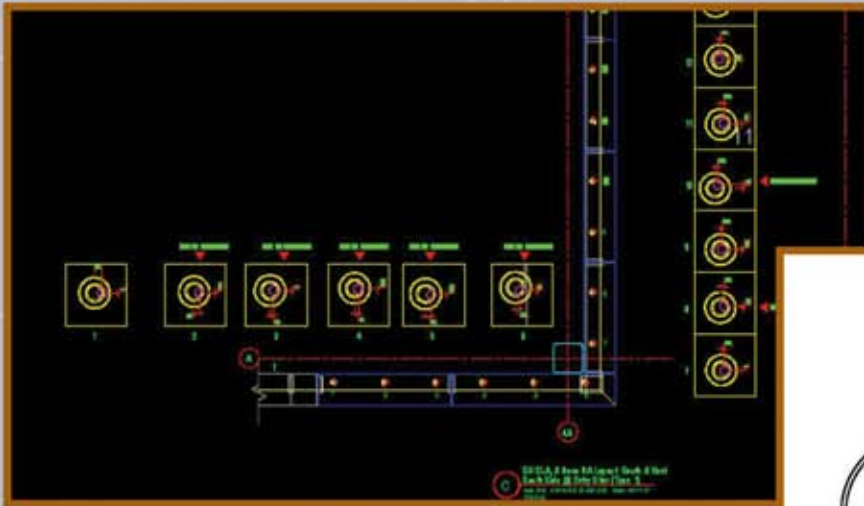
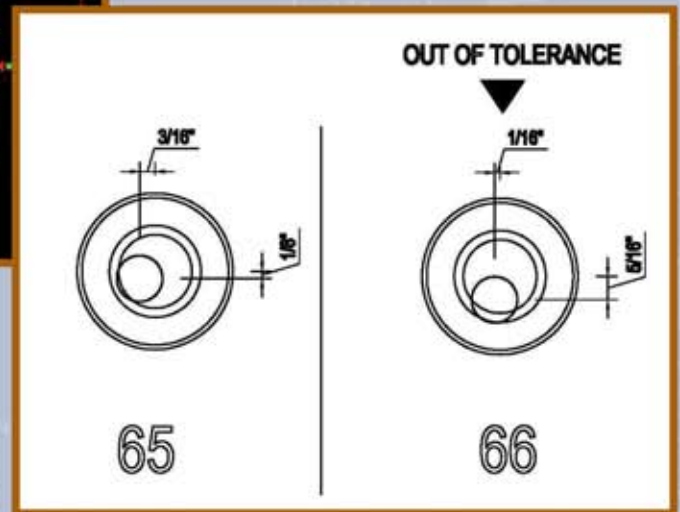
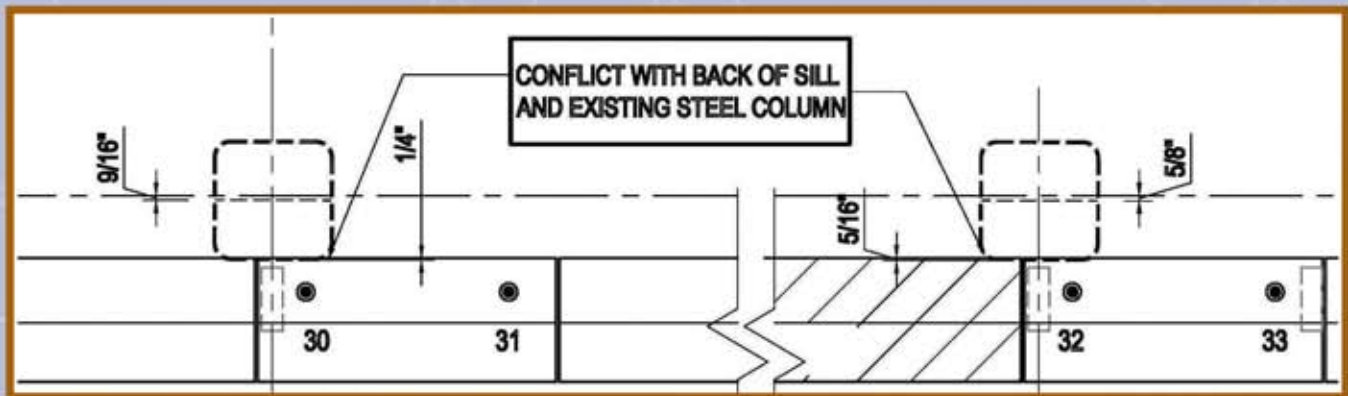
The approved shop drawing is overlaid on the scan data creating a precise existing conditions document. Which will allow analysis of the site conditions, and coordination of the various trades.

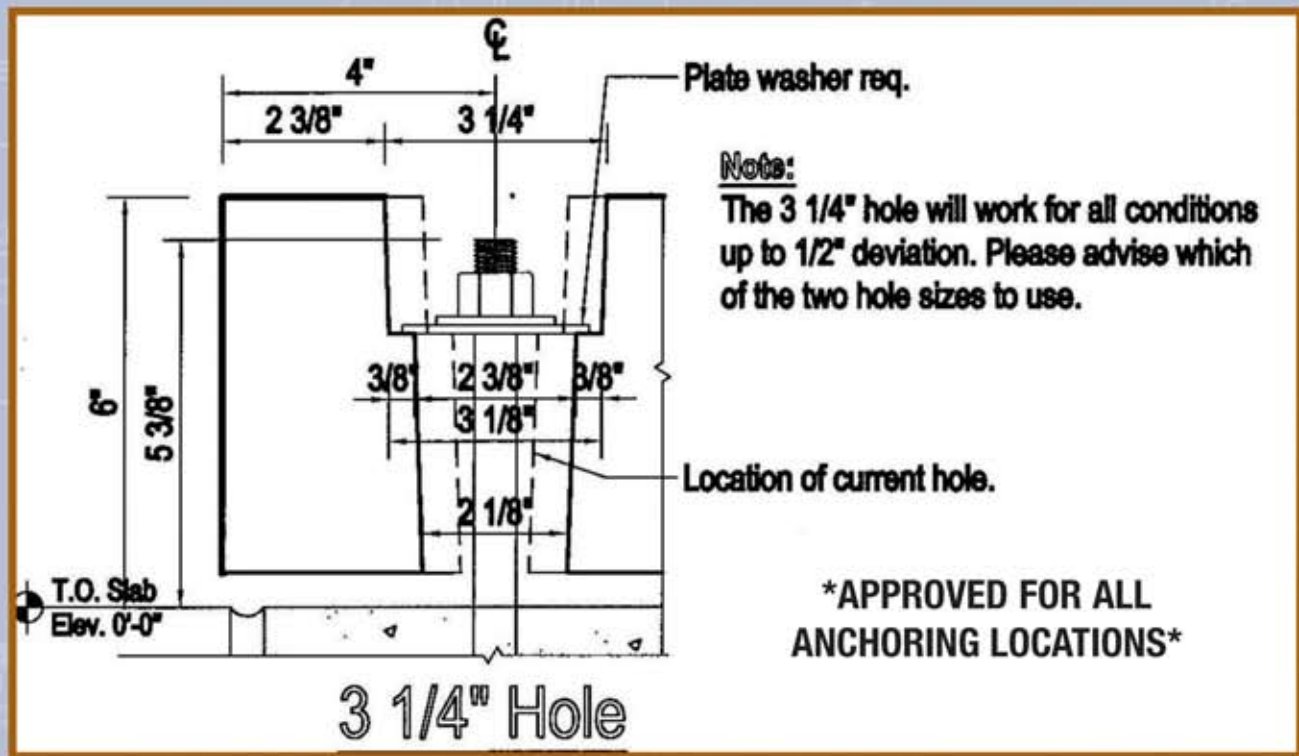
While the scope of work included only producing accurate as-built drawings of the anchor bolts, a thorough inspection of the 3D scans showed that the structural steel was placed incorrectly. An error normally not detected until the stone setter mobilized and the material was onsite. This information allowed a NO COST solution to be achieved... the stone was simply fabricated with a knock out in the mold.

YES – a simple NO COST solution was executed... simply installed a knock out in the mold before the stone was cast alleviating the need for the stone setter to modify the cast stone onsite.
