LASER TECHNOLOGY BUILDING DOCUMENTATION SPECIALISTS

Verizon Building Syracuse, NY

Client: Lupini Construction

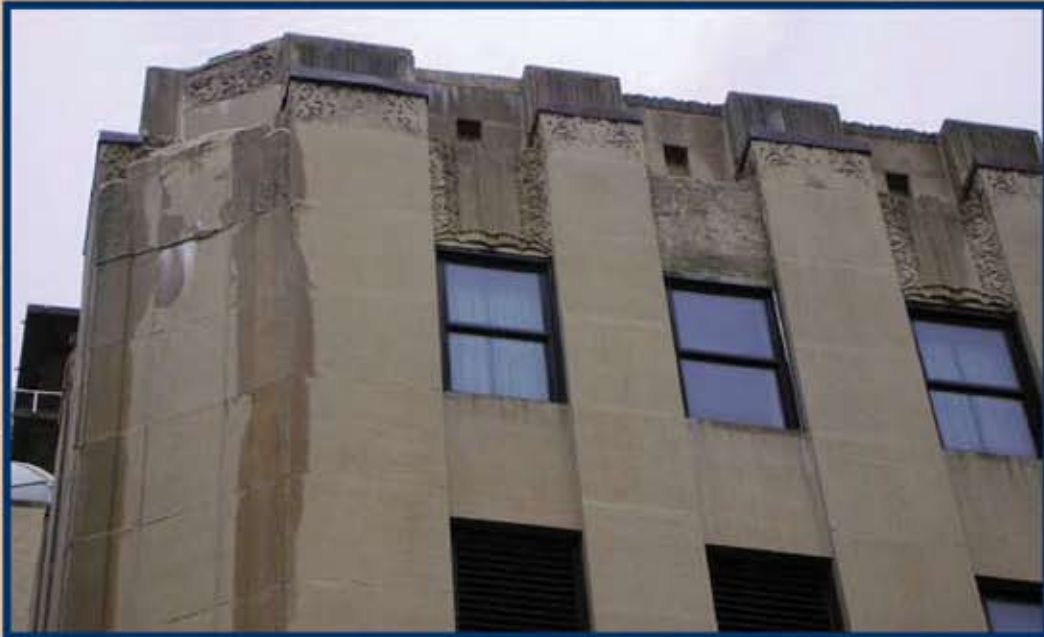
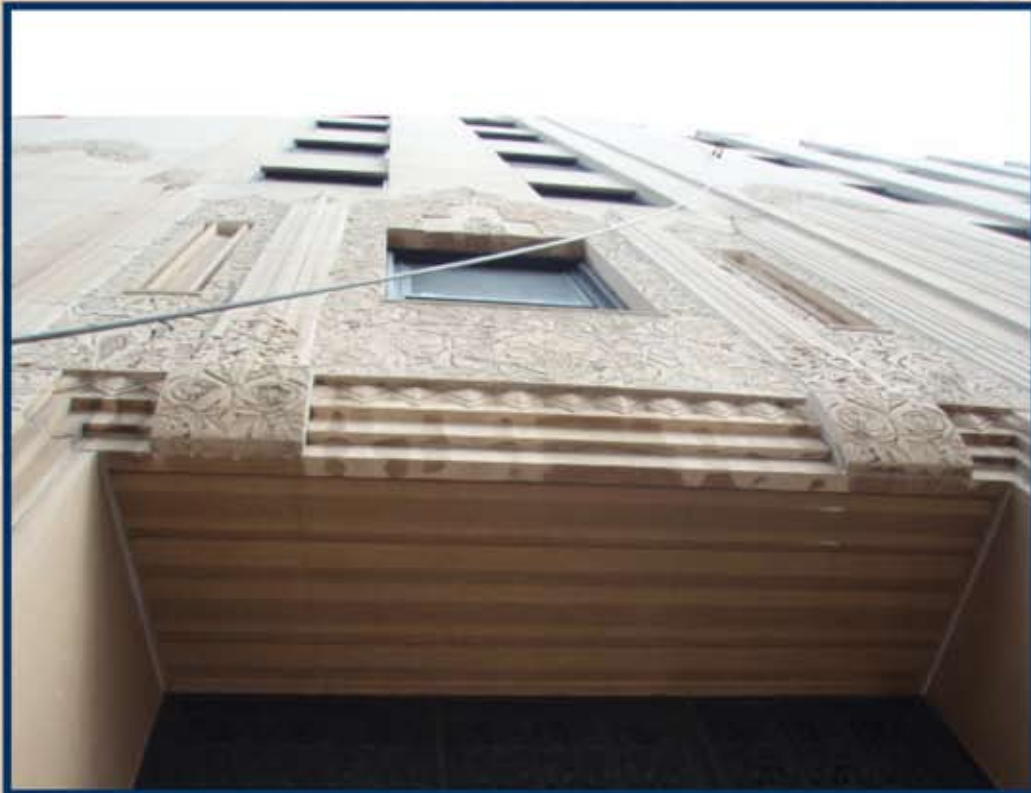
The decorative cast stone panels at the top of the building had undergone severe weathering and deterioration. Their poor condition and fragile state eliminated possibility of removal for creating molds in a controlled environment.

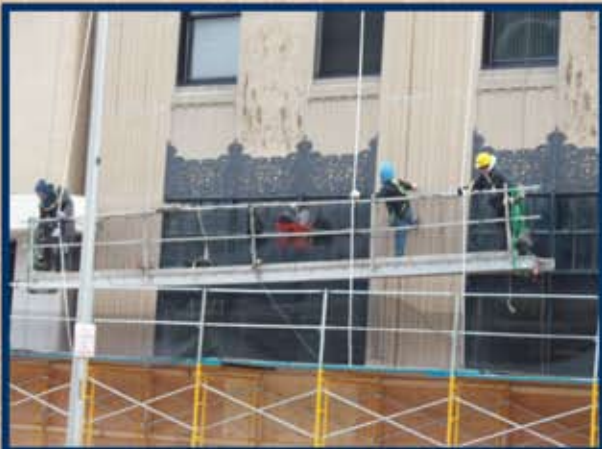
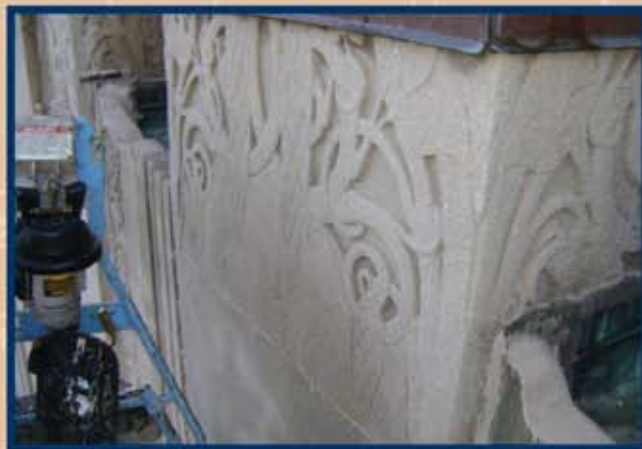
Using swing scaffolds, Corinthian Data Capture's technicians hand scanned the decorative cast stone elements, acquiring a digital map of the intricate surface variations and details.
