Terracotta Replication

Using Laser Scanning Metrology

CORINTHIAN
DATA CAPTURE, LLC

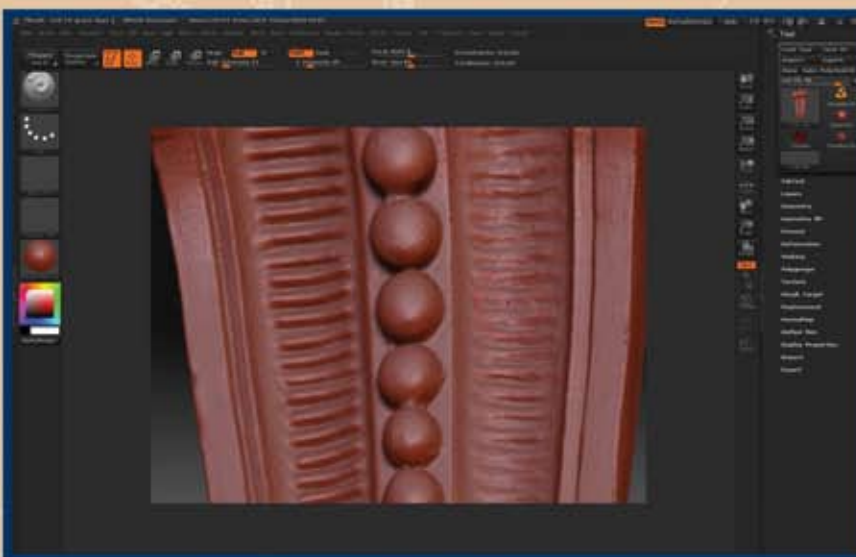
Left:
Decorative bracket is being digitally sculpted to restore the fine detail lost over time.

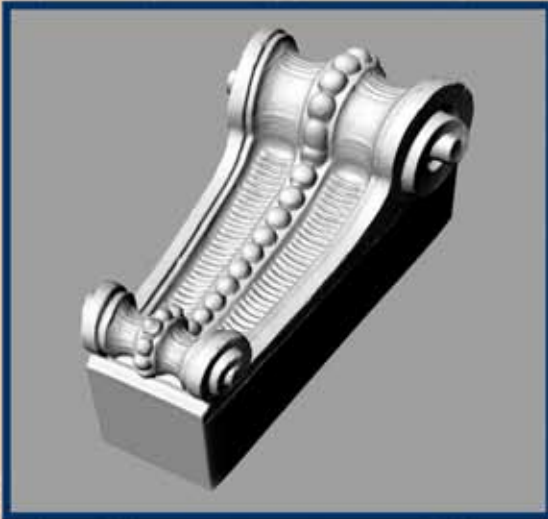
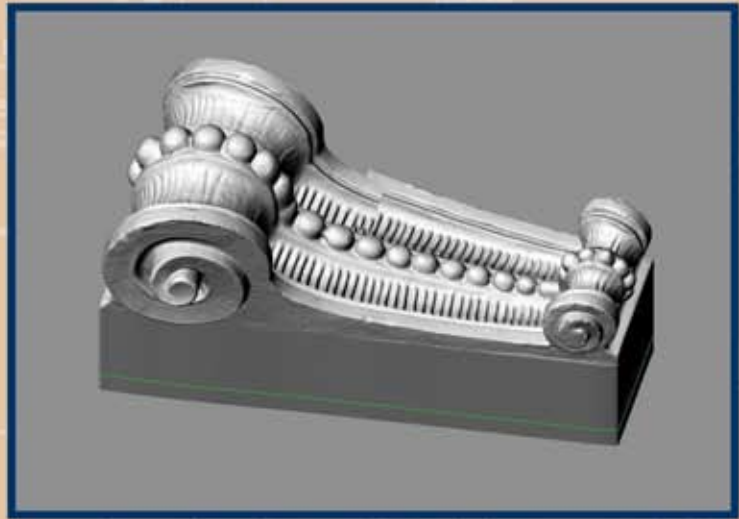
Above:
Decorative bracket has been completely remodeled and is ready to be sent to the CNC machine for positive creation.

Left:
The CNC carved model/positive which will be used to make a mold in our manufacturing facility, under controlled conditions.

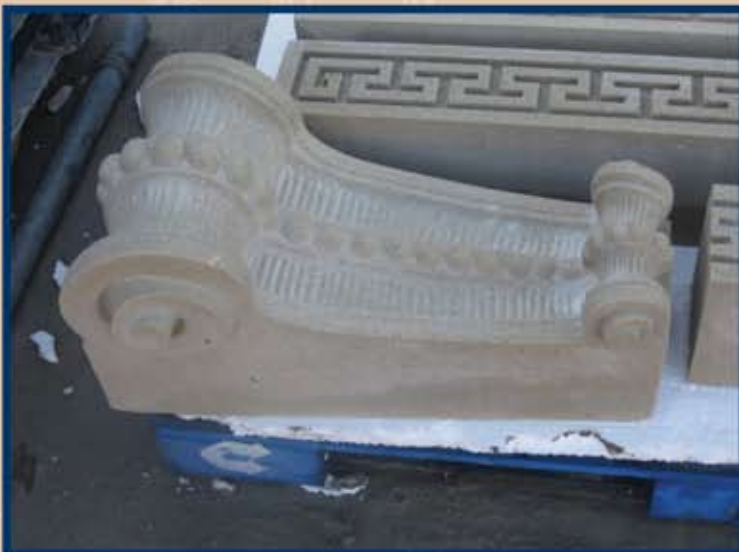
Below:
Finished product – cast stone unit that matches the original terracotta detail exactly.

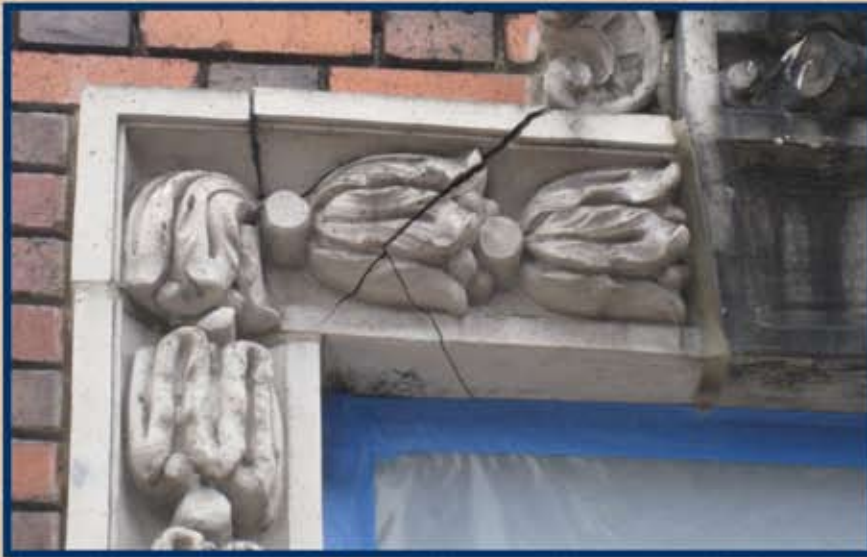
Original broken terracotta – if this was to be removed, it would fall apart resulting in many additional hours of work and significant cost, to put “Humpty Dumpty” back together again.

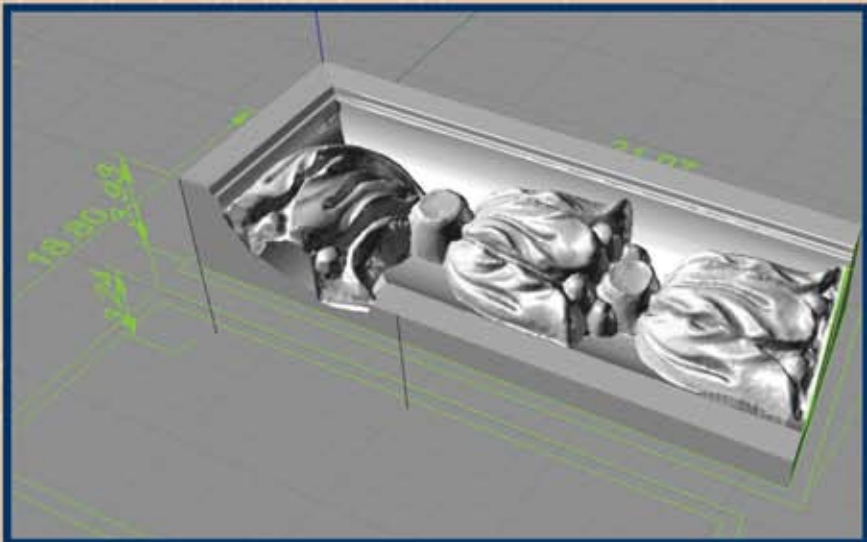
Digital restoration of the scan of the architectural element – restored to its original condition.

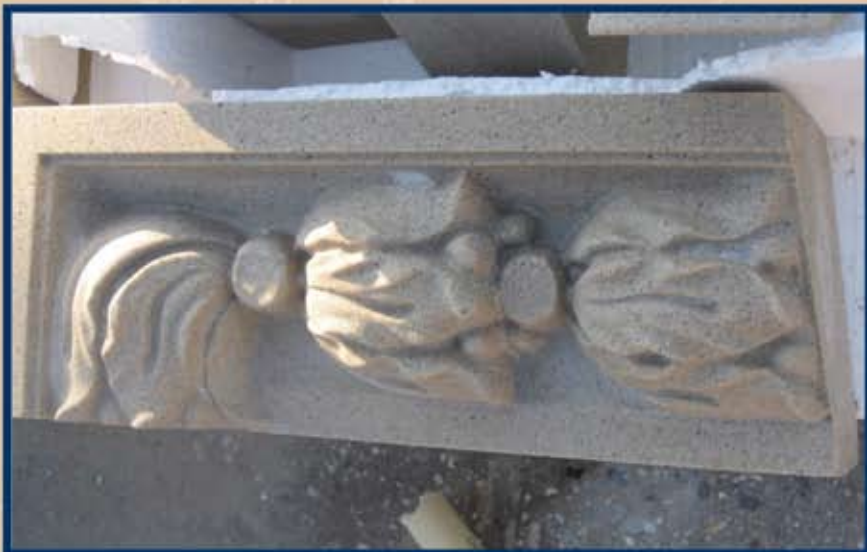
Fabricated cast stone unit to be installed.

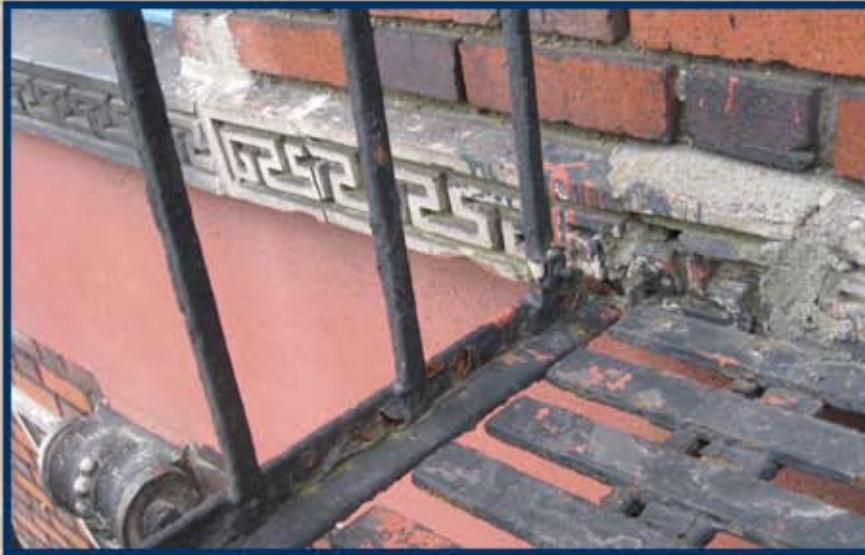
The Greek key band and sill have been abused by time and building renovations.

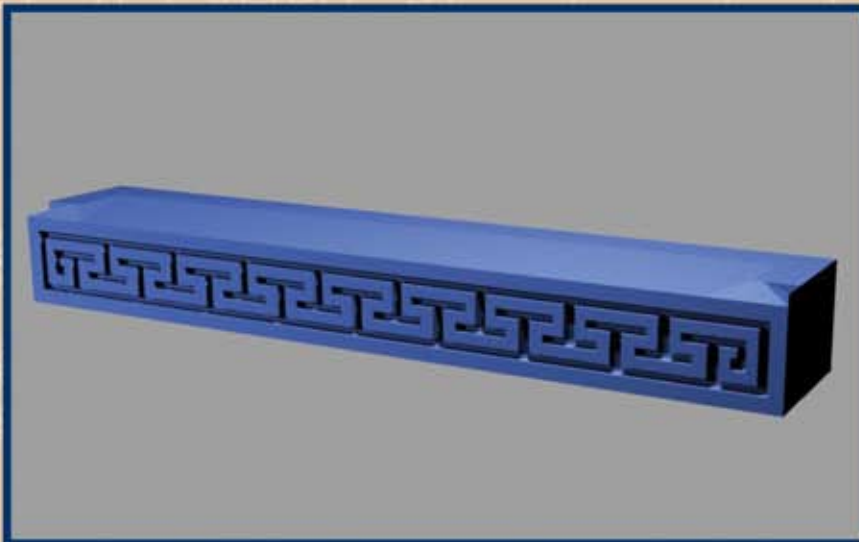
Scan and 3D model of the new Greek key window sill.

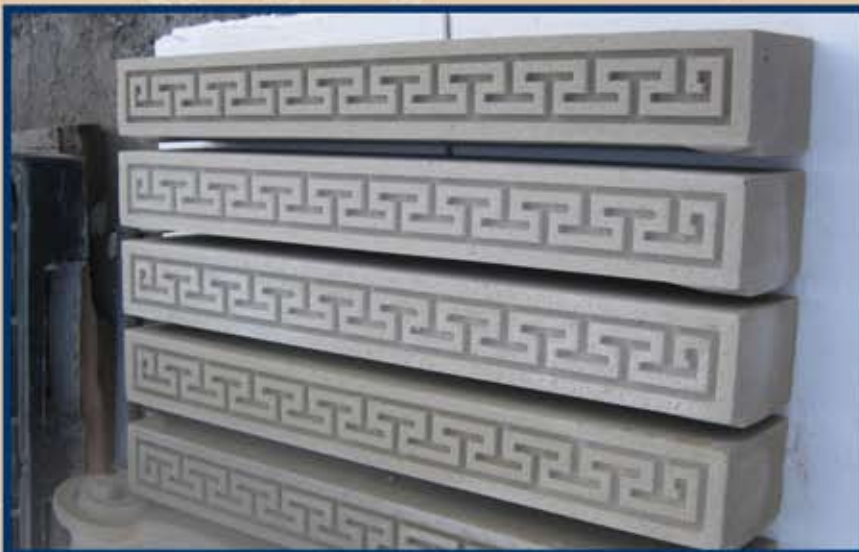
New cast stone units ready to be installed.
