# NYC DOT Sunrise Yard Facility

## Cast Study: Anchor Bolt Laser Scan Survey

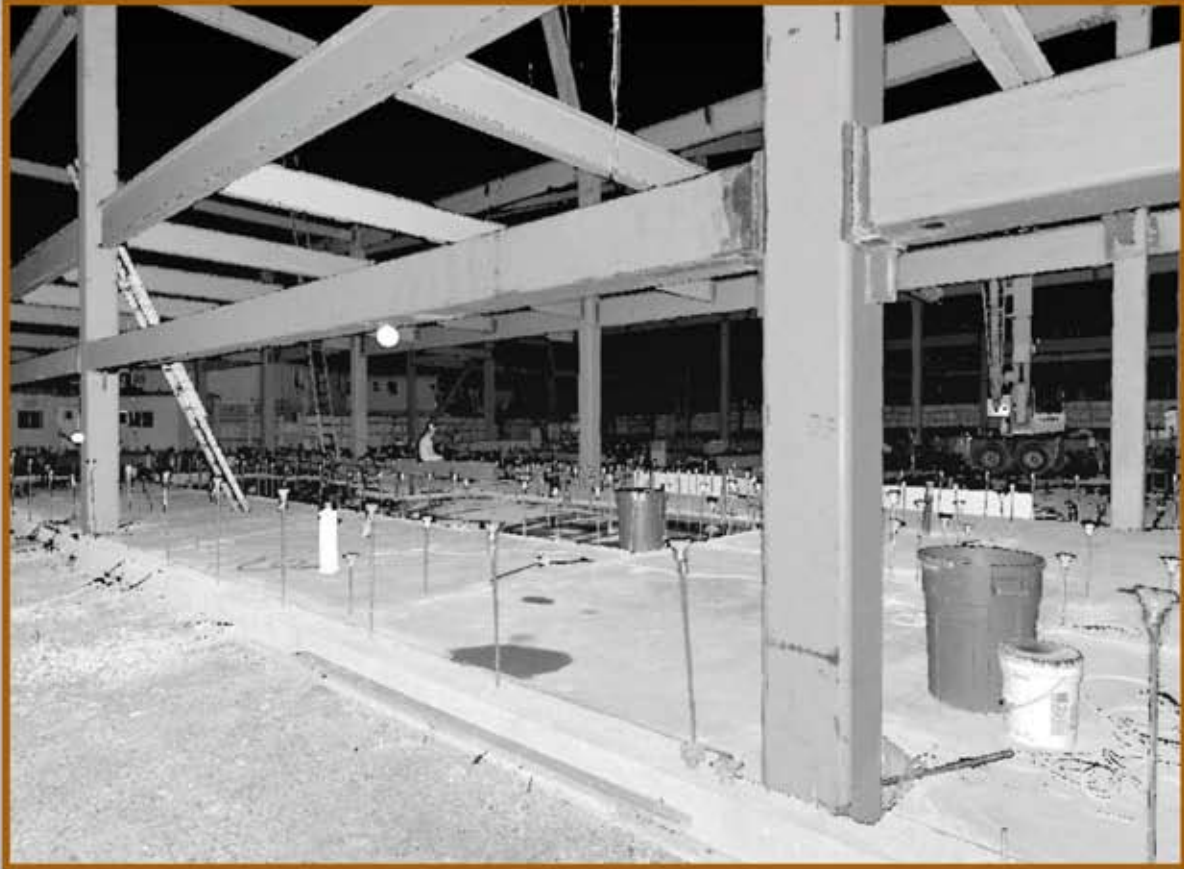
Construction was underway, awaiting installation of the cast stone sill set under the curtain wall. Each stone unit was detailed with through holes to accept the anchor bolts used to fix the sill to the foundation then to the curtain wall.

- Are the anchor bolts correctly located?
- Are there any conflicts with the steel columns and setting the cast stone?

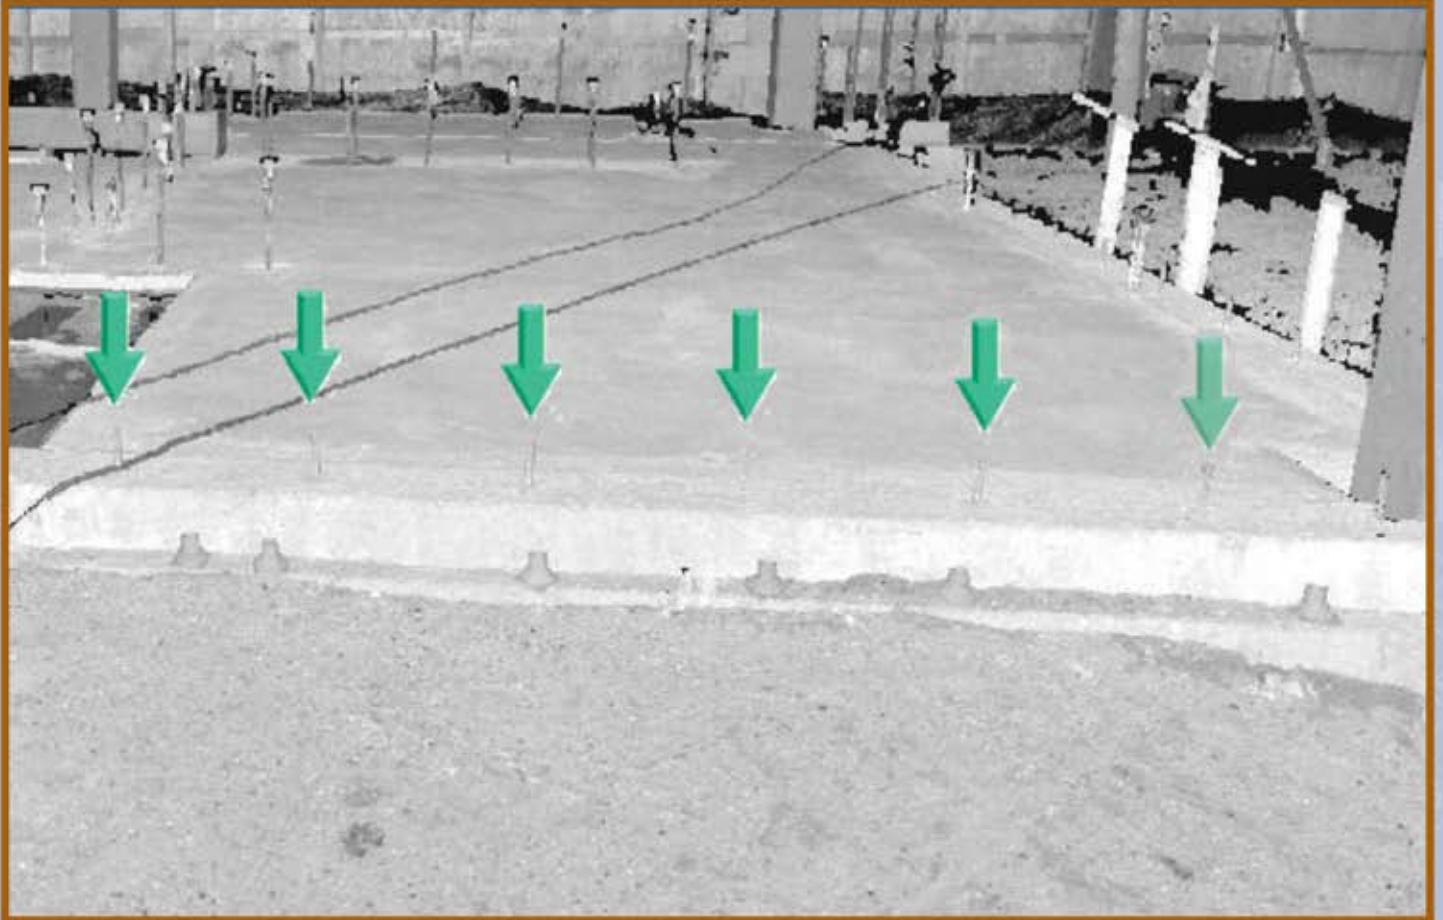
All existing anchor bolt locations are digitally captured in 3D space.
